## RECORD OF CONVERSATION

**Joshua Lindberg**  
**Air Safety Investigator**  
**Central Region**

**NTSB Accident Number:** CEN17FA127

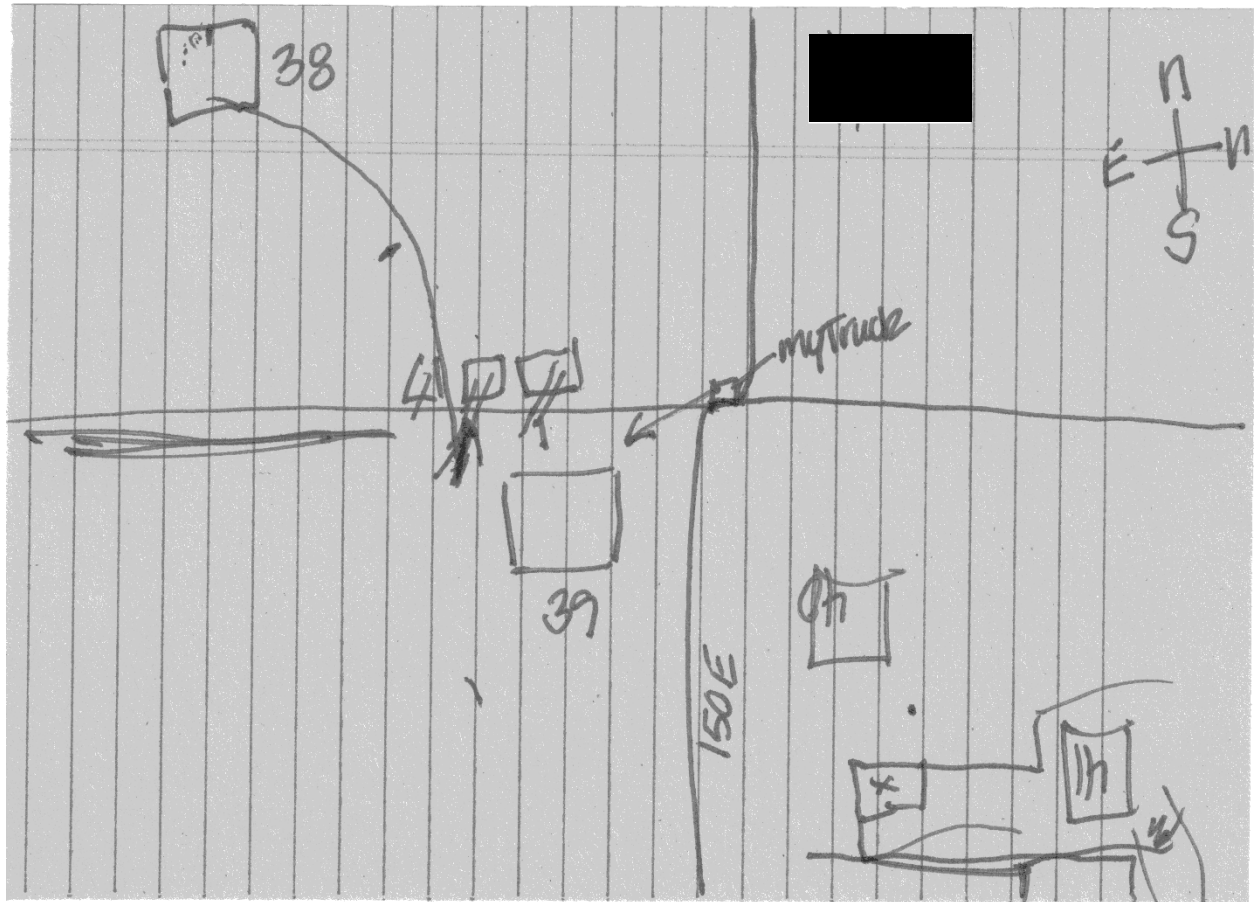
- The needle didn’t look like it hit the tower
- The needle is visually inspected by the helicopter operator and pilot before the flight
- He drew a map of the accident area which is attached to this record of conversation
